TECHNICAL REPORT ARCCB-TR-03008

**EROSION MODELING OF THE HIGH CONTRACTION
CHROMIUM PLATED CRUSADER GUN SYSTEM**

JUNE 2003

**US ARMY ARMAMENT RESEARCH,
DEVELOPMENT AND ENGINEERING CENTER**
Close Combat Armaments Center
Benét Laboratories
Watervliet, NY 12189-4000

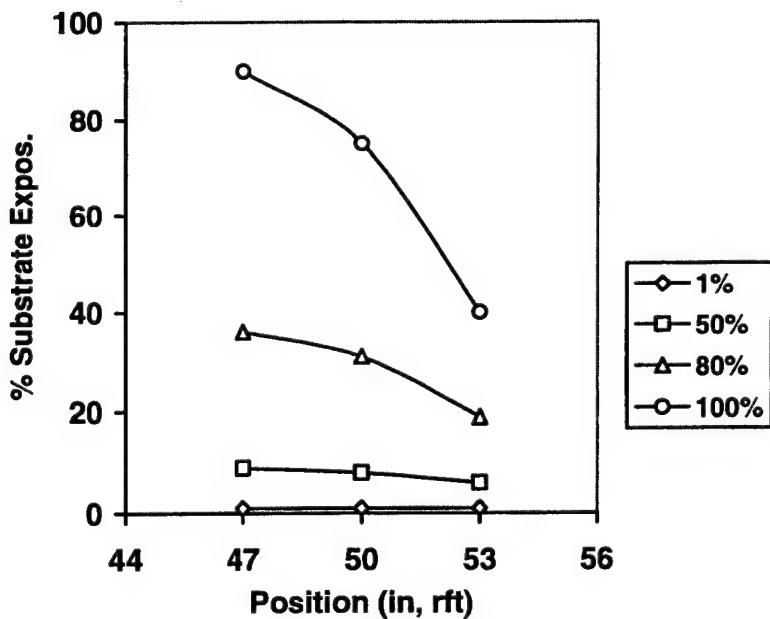
Figure 8 shows percent groove substrate exposure versus the selected origin axial positions for this gun system at 8 rpm, and the 10:00 to 2:00 clock position. These were measured at 1% (nondestructively measured at post-proofing), 50% (exponentially estimated from nondestructive measurements), 80% (exponentially estimated from nondestructive measurements), and 100% (nondestructively measured and destructively measured near erosion condemnation) of this equivalent ambient-conditioned zone six charge erosion life. Groove

Figure 8. Groove substrate exposure versus selected axial position for 8 rpm and 10:00 to 2:00 position at 1, 50, 80, and 100% equivalent life.

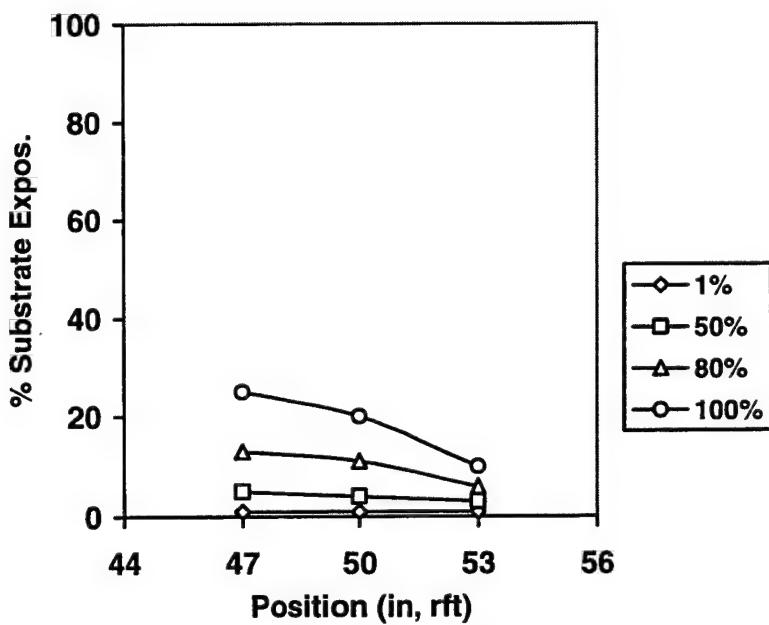
Similarly, Figure 9 shows percent land substrate exposure versus the selected origin axial positions for this gun system for 1 rph, and the 10:00 to 2:00 clock position. These were measured at 1% (nondestructively measured at post-proofing), 50% (exponentially estimated from nondestructive measurements), 80% (exponentially estimated from nondestructive measurements), and 100% (nondestructively measured and destructively measured near erosion condemnation) of this equivalent ambient-conditioned zone six charge erosion life. Land erosion dominated over groove erosion for this gun system's 1 rph firing rate, based on the rate of land erosion in tubes 2, 7, and a number of other tubes that experienced this low firing rate. Substrate exposure for lands would have much higher percentages if they were only for the driving edge and not averaged over the whole land.

Figure 9. Land substrate exposure versus selected axial position for 1 rph and 10:00 to 2:00 position at 1, 50, 80, and 100% equivalent life.

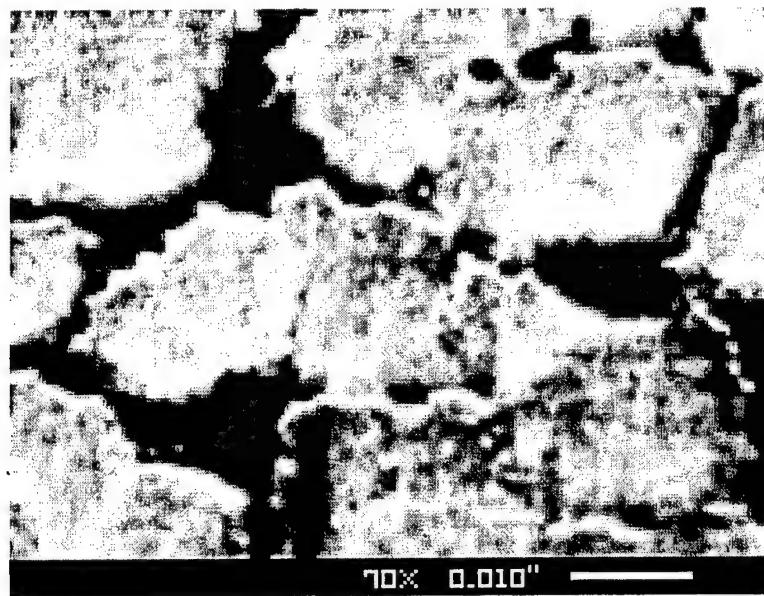
Figure 11. Typical midlife groove erosion by magnifying borescope at 47 inches from RFT, 10:00 to 2:00, and 8 rpm firing rate.

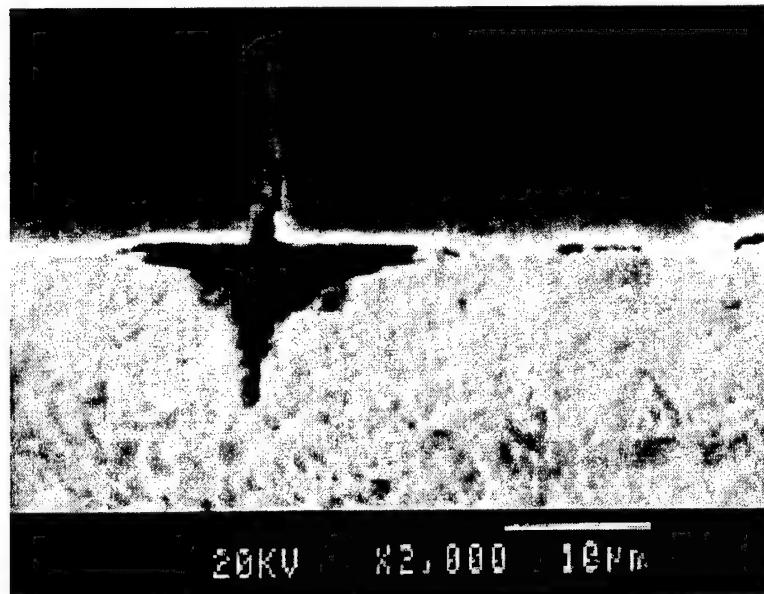
Figure 12 shows a micrograph from this gun system with typical 47-inch from RFT, 10:00 to 2:00 clock positions, and land and groove steel substrate erosion through a microcrack. This destructive substrate exposure characterization is from an SEM, although similar characterizations were made by a metallograph. This and other cross-sections were taken away from groove pits and land pits at middle tube life, 47-inch from RFT position, and at 2000x. The inverted triangles (about 15- x 15- μm) in the steel substrate are almost universally present at the base of the fine HC chromium crack (about 1- μm wide) for both land and groove erosion, although their rate of erosion varied with the zone six charge firing rate. The damage to this steel substrate is caused by high-pressure combustion gas filling from each round. To put into perspective the small size of the inverted triangles and crack width, the HC chromium plate thickness is about 130- μm . In addition, typical land and groove interface degradation and voids are present in this figure to the right of the inverted triangle. This figure shows the initiation of erosion that progresses and accelerates with HC chromium crack widening, substrate steel interfacial damage, HC chromium platelet spalling, micropitting enlargement to macropitting, and substrate steel gas washing to condemnation.

Using coupled chemical analysis techniques, characterizations of the micrographic region shown in Figure 12, and other similar micrographic regions, show phase change degradation (diffusion-induced carburized white layer and heat-affected zone on/into exposed gun steel, chromium recrystallization) and chemical reaction degradation (oxygen and sulfur oxidation of exposed gun steel forming semi-metallic layers) of the gun steel substrate under the HC chromium plate at crack and interfacial walls/wall layers.

Figure 12. SEM cross-section of typical land and groove steel substrate erosion through a microcrack at 47 inches from RFT and 10:00 to 2:00 position.
